DNA-TR-82-18

## DUST-CLOUD EFFECTS ON AIRCRAFT ENGINES-EMERGING ISSUES AND NEW DAMAGE MECHANISMS (U)

A Case Study of a Mt. St. Helens Experience and its Implications for Nuclear-Weapon-Lofted Dust-Cloud Effects (U)

Technical Report

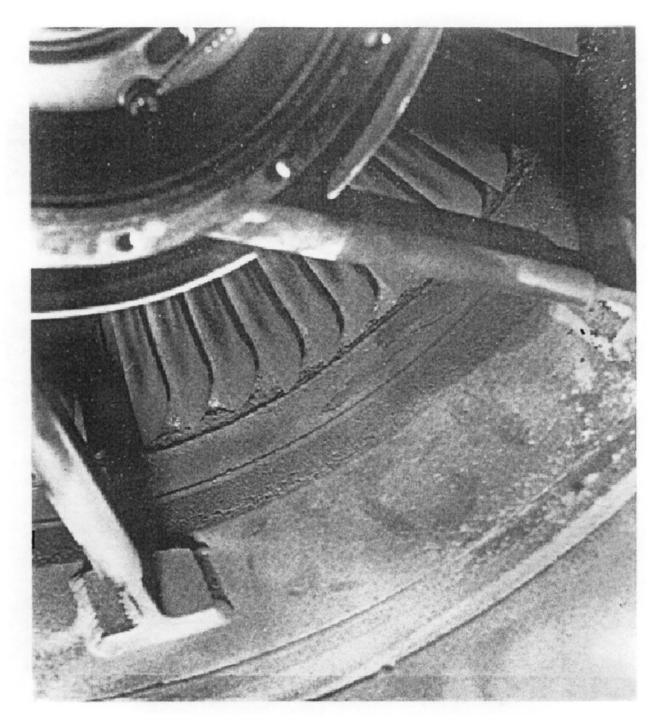
Figure 4. Turbine blades and housing.

deformation from deposition and erosion, and burned and cracked airfoils (Figs. 2 and 3). All second—, third— and fourth—stage vanes exhibit erosion (burn damage) to their airfoils (Figs. 2 and 4). All blade tips on all stages are eroded away (burned off) to varying degrees (Fig. 5). Thermocouple sampling orifices are plugged with deposited material (Fig. 6). This turbine reportedly had a heavy ingestion of volcanic ash.

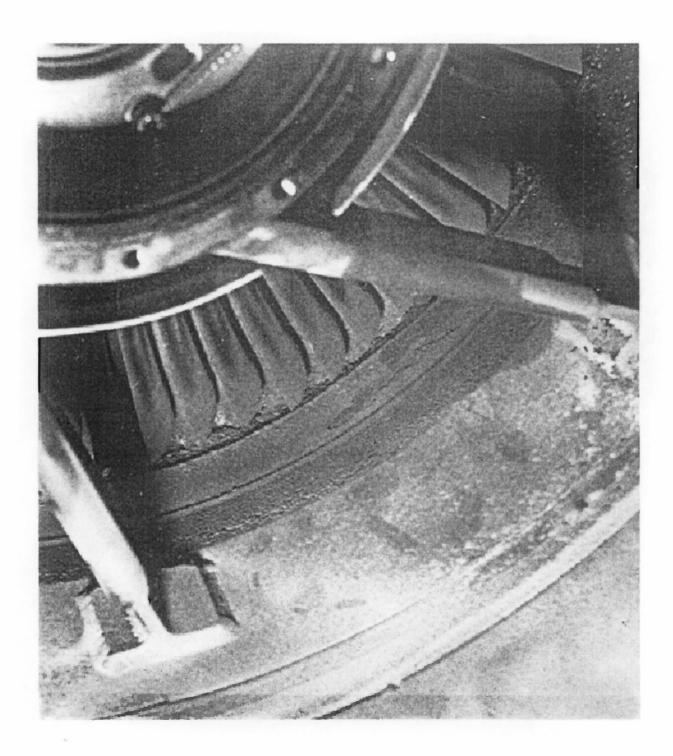
Figure A3. Turbine blades and housing.
